**COMPLETION INSPECTION REPORT for:  
SAMPLE**

Inspected Property:  
67A Pentecost Avenue, SAMPLETON

Reference Number:  
Sample Completion Report

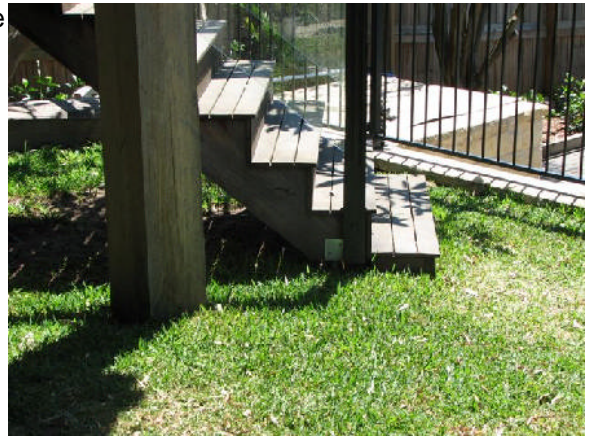
The stairs are constructed primarily from timber. Timbers are in contact with soil and modifications are required to prevent timber pest damage.
